Passive Fire Protection Review

Site: Cestrian Court (11358)
Address: Newcastle Road,
Chester Le Street,
Durham,
DH3 3TD
Client: FirstPort
Visit Date: 9th July 2020
Author: Joe Nims BSc Hons
Review Date: N/A

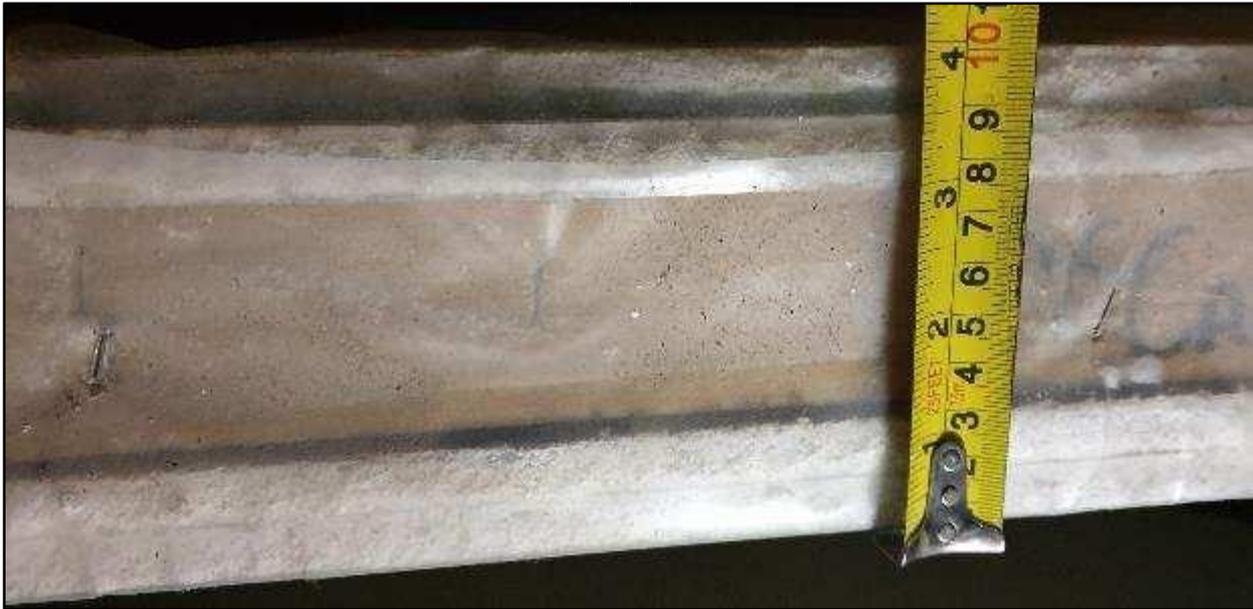
Cross section of plasterboard on timber studwork compartment wall separating roof voids.

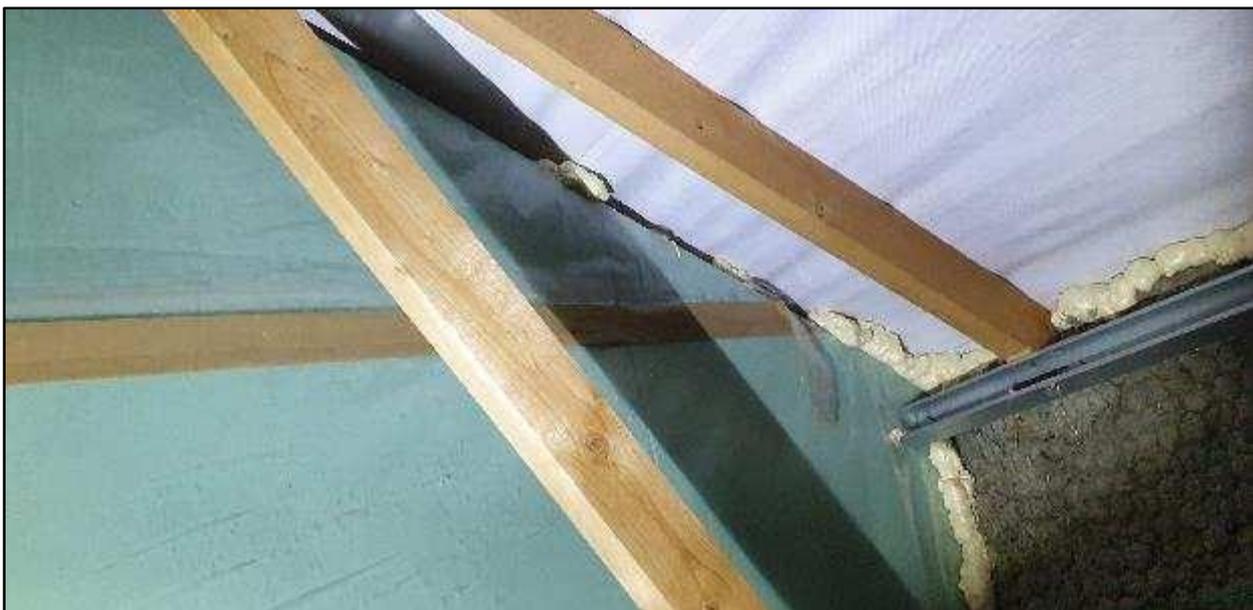
Firestopping at junction of plasterboard compartment wall in roof voids was achieved by compressed mineral wool slabs. Due to the movement of the building over years, this fire stopping has become dislodged in many places. In some areas attempts have been made to replace it with expanding foam.

View of plasterboard compartment wall with missing mineral wool fire stopping and expanding foam in place.

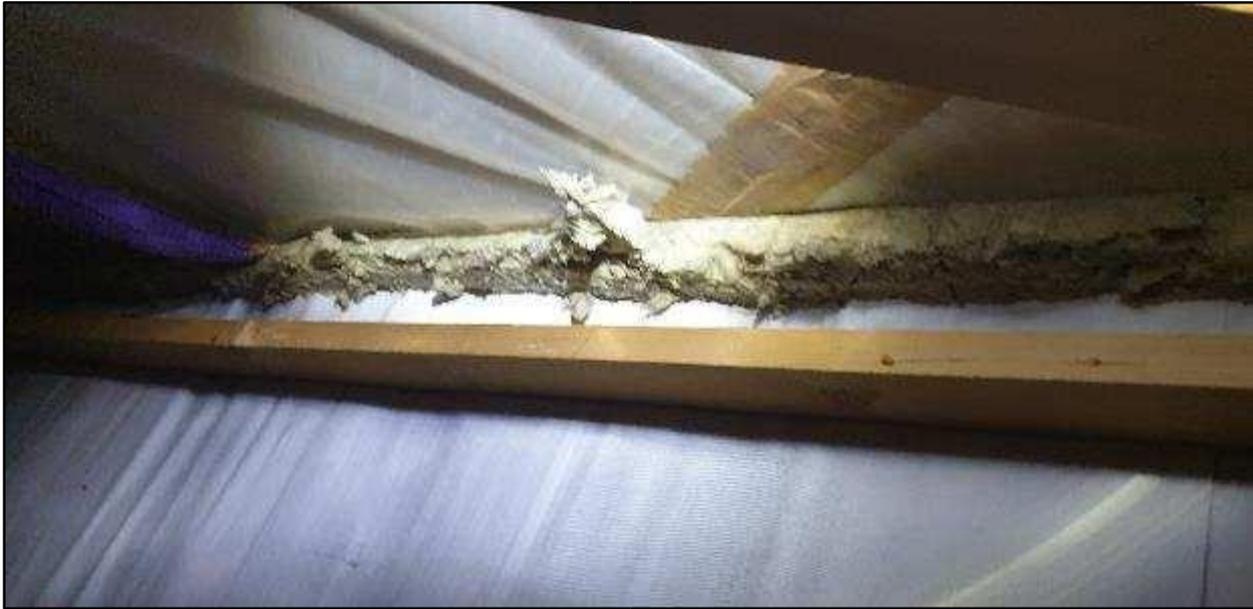
Example of mineral wool fire stopping in place.

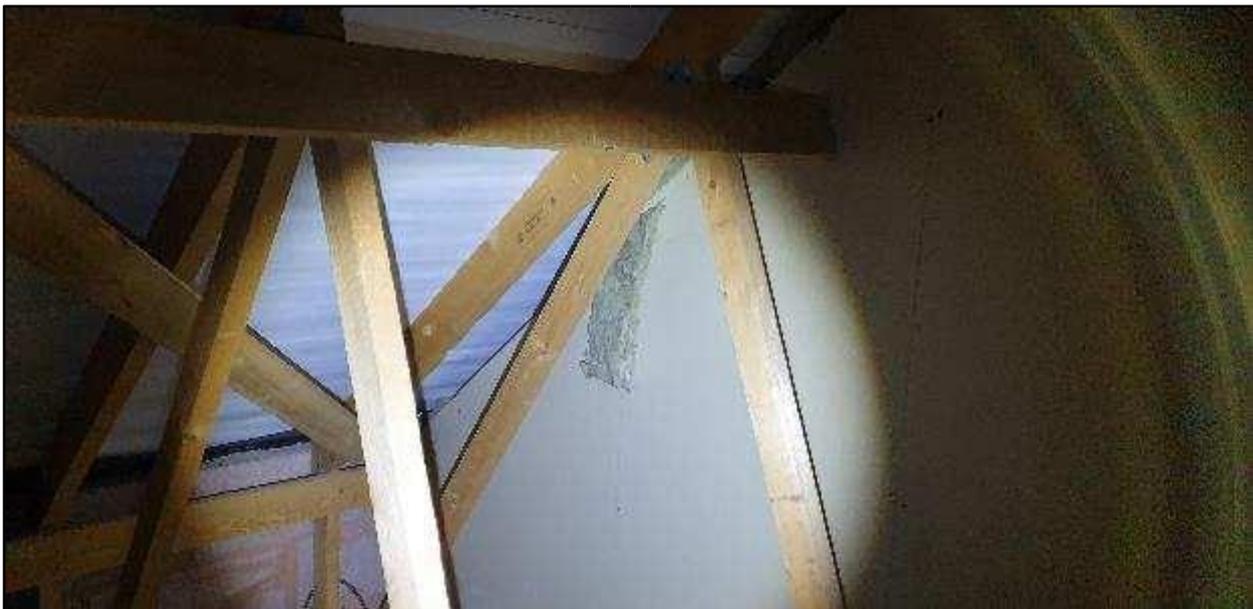
Example of partially dislodged mineral wool fire stopping.

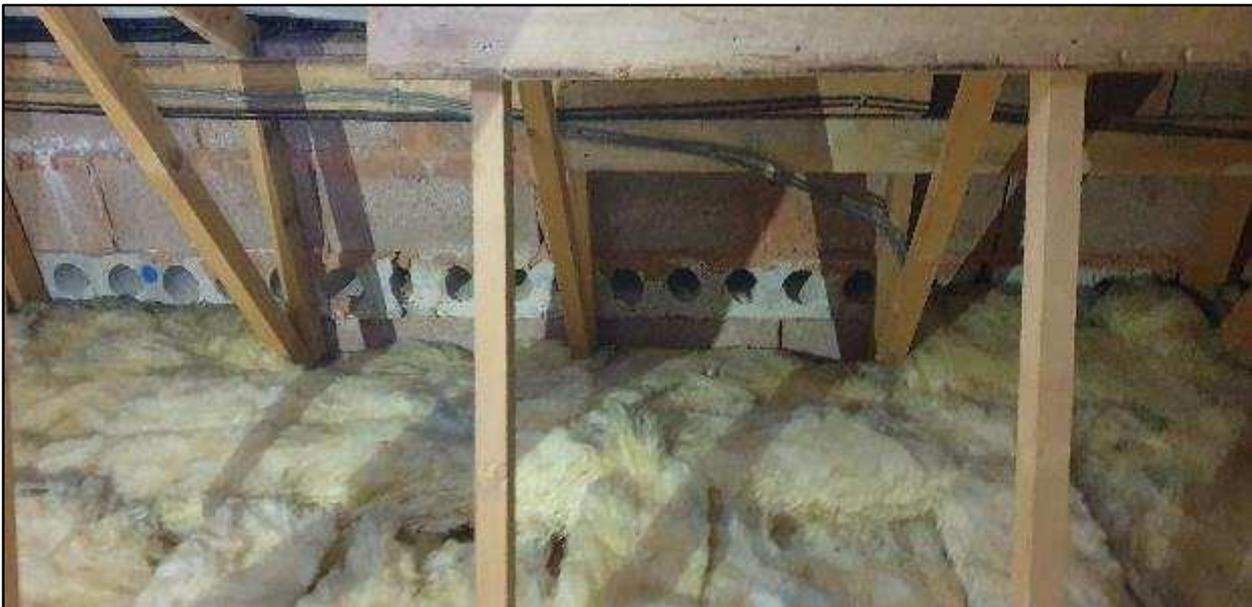
The top floor corridors are covered with concrete slabs which have full length holes connecting roof voids either side of the corridor. Some of the slabs had these holes fire stopped with mineral wool but the majority of these holes were not fire stopped, and some had been covered over with PUR/PIR foam slabs.

Example of concrete slab with holes over top floor corridors view from roof void.

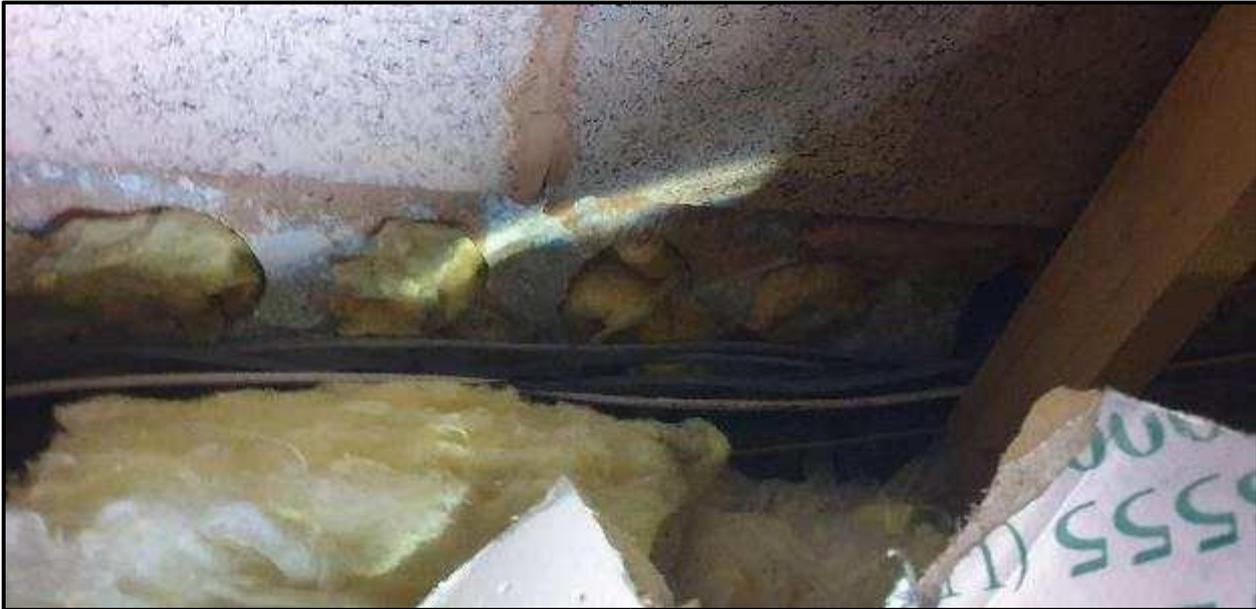
Example of holes in slabs fire stopped with mineral wool.

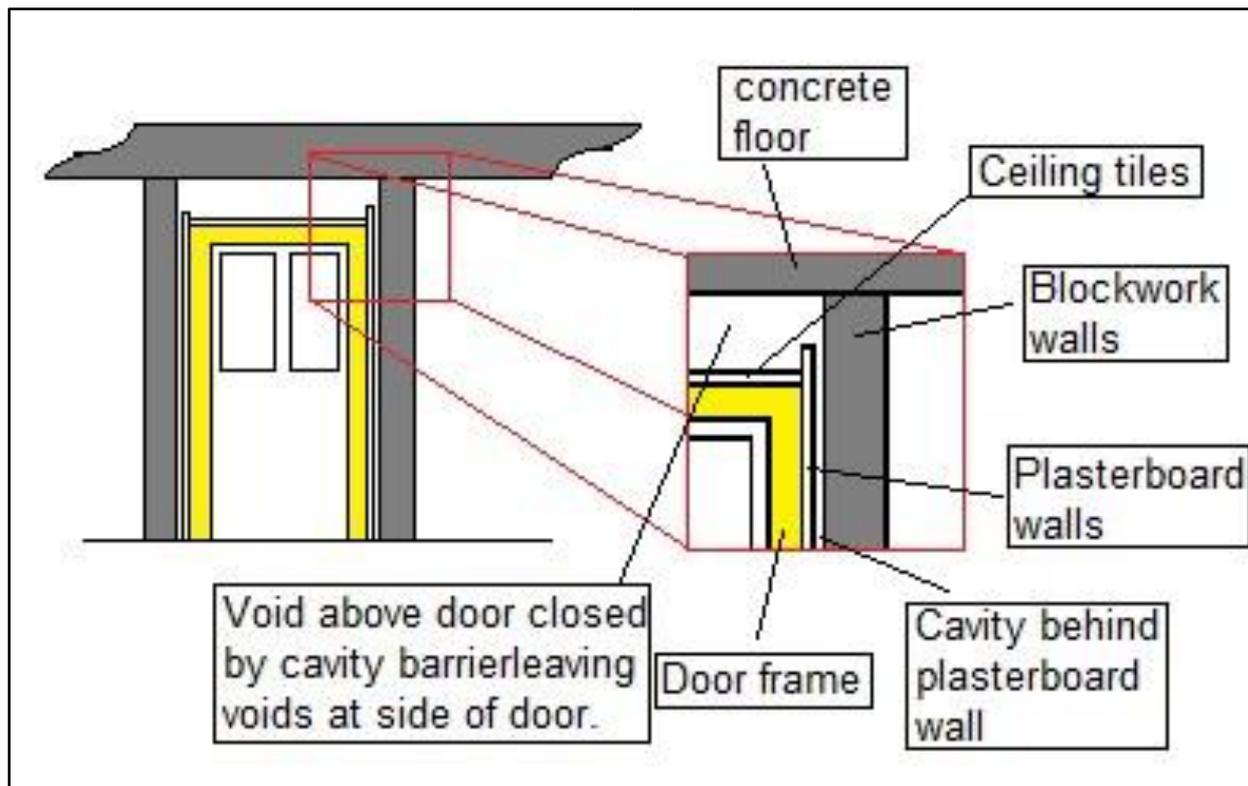
Cross corridor doors frames were attached to corridor plasterboard walls which were mounted on dab and daub method which creates a void behind plasterboard walls which by-passes cross corridor doors.

Diagram of construction of CCDs showing void created by dab and daub method of affixing plasterboard walls.

<p>Due to the use of the dab and daub method of affixing plasterboard sheets to blockwork walls in communal areas and cross corridor fire door frames were mounted to the plasterboard walls rather than the blockwork wall beneath there were voids by-passing the cross corridor doors (These voids were also open to the ceiling void).</p> <p>This defect is considered not to have met the guidance at the time of construction.</p>	<p>plaster for the voids behind board either: walls to be sealed by</p> <ul style="list-style-type: none"> a) Firestopping of plasterboard walls to blockwork wall in ceiling void of corridors to a 30 minute fire resisting standard using intumescent mastic. b) Cutting of plasterboard at cross corridor doors and the insertion of a timber batten at least 38mm thick affixed to the blockwork wall. <p>Note: re to the ceiling tiles requiring d mounted to seal all tions from ceiling void to flats w), option A above will (y be the best option.</p>	<p>3</p>

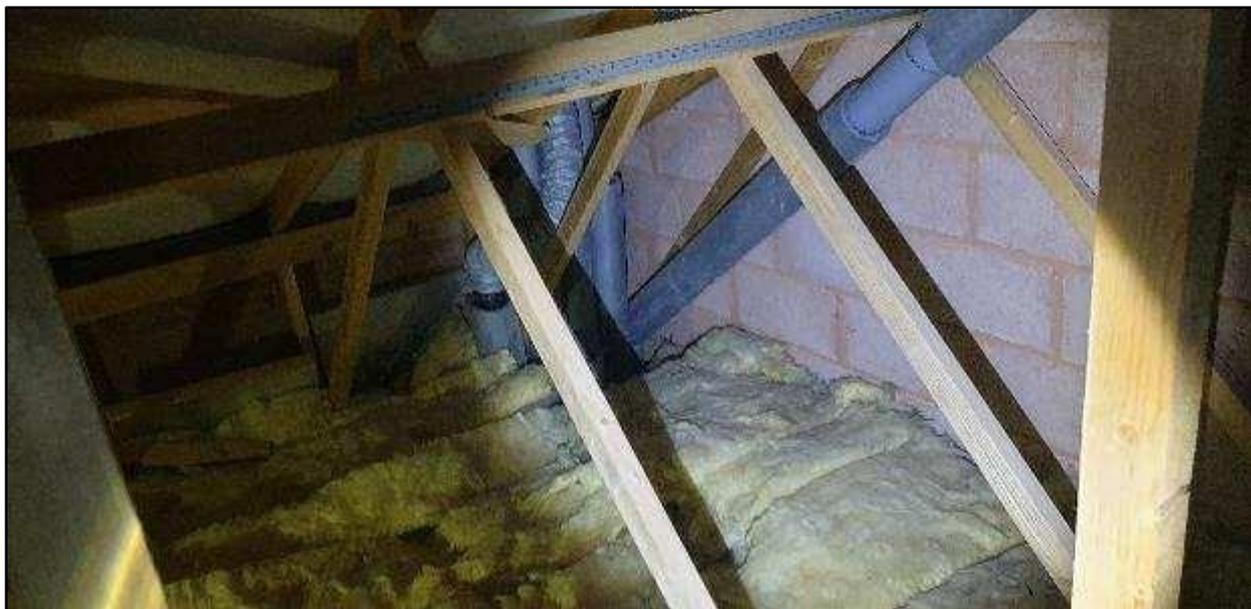
Communal vents discharged from a communal riser through the top floor roof space, it was unknown if all openings to flats had been fitted with appropriate fire dampers.

Example of communal vents discharging from communal riser through roof void.

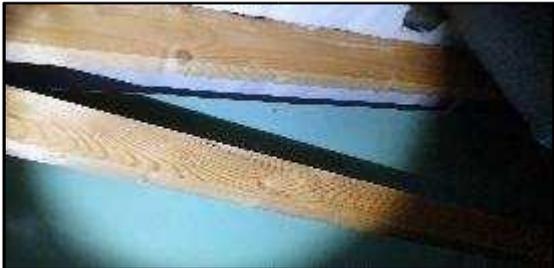
Defect	Remedial Action	Action Plan Year
<p>Firestopping between plasterboard compartment walls and roof in roof voids had become dislodged in many areas, with some fire stopping being replaced by expanding foam.</p> <p>This defect appears to be caused by slippage of mineral wool due to expansion and contraction of roof, this is considered not to have met guidance at time of construction as Approved Document 'B' requires cavity barriers to be mechanically fixed where possible (in the case of fire stopping it states that the fire stopping should be resilient).</p>

<p>Example of missing mineral wool fire stopping.</p>	<p>Arrange for gaps where mineral wool fire stopping is missing/loose or has been replaced by expanding foam at wall/roof junction to be replaced by densely packed stone wool held in place by intumescent mastic or plasterboard cover providing a minimum fire resistance of 60 minutes.</p>	<p>1</p>

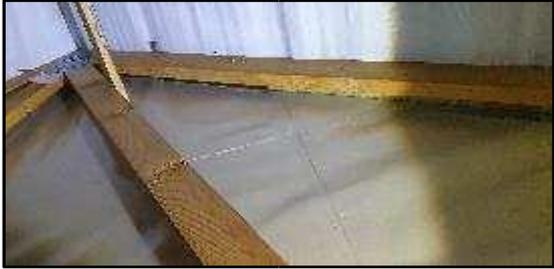
<p>Plasterboard sheets forming the compartment walls in roof voids were not taped and sealed.</p>

<p>Example of plasterboard joint not taped and sealed.</p> <p>This defect is considered not to have met the guidance at the time of construction.</p>	<p>Arrange for plasterboard joints to be taped and sealed.</p>	<p>1</p>

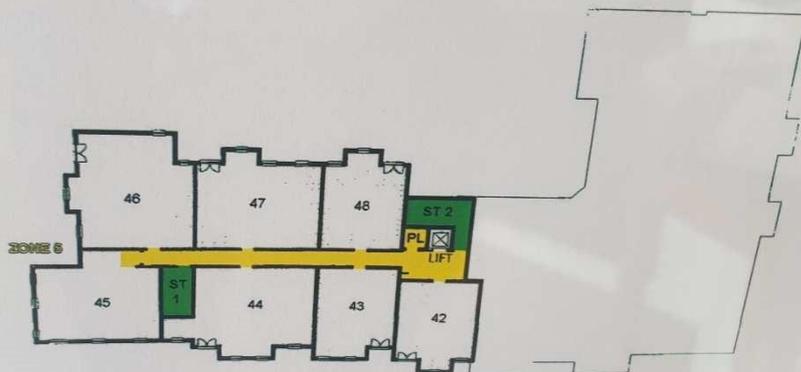
Alternative Year 1 loft areas flats 42 – 48 and staircase.

Due to the cost effectiveness of remediating all the defects in roof voids at once, i.e. Year 1 & 2 action plan (see defects above and below relating to loft spaces); all defects in loft spaces may be addressed at the same time:- loft spaces above flats 42 to 48 in year 1 and those above 26-34 in year 2, i.e. 2nd floor lofts in year 1 and 1st floor lofts in year 2. Year 3 actions will remain the same.

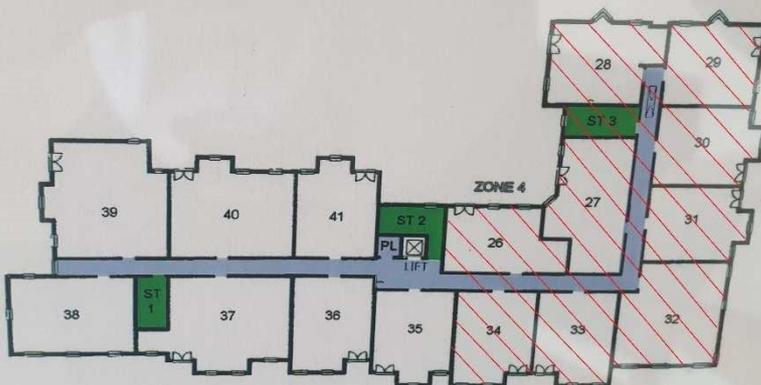
Alternative Year 2 loft areas shown hatched in red.

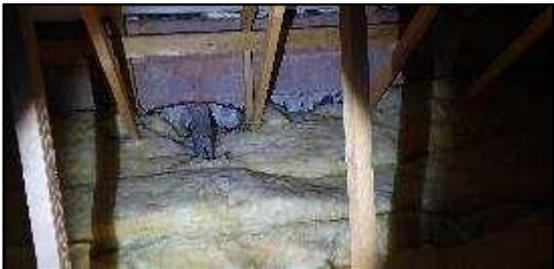
<p>Example of holes in concrete slab linking roof voids which are not fire stopped.</p>	<p>Arrange for all holes in concrete slabs and gaps between slabs to be fire stopped to a minimum fire resistance of 60 minutes. This may be by fire batts sealed with intumescent mastic or by densely packed stone wool to an appropriate depth.</p>	<p>2</p>

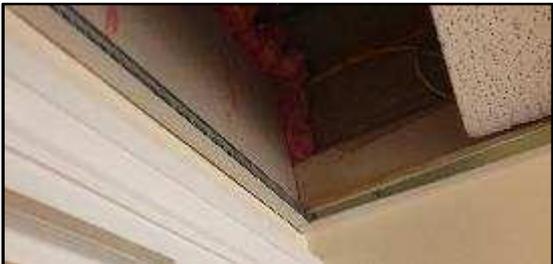
<p>Cavity barriers located above cross corridor doors were inadequately fire stopped – inappropriate use of expanding foam, mineral wool not densely packed, gaps at edges of plasterboard/cable trays and plastic pipes greater than 40mm in diameter not fitted with intumescent collars.</p> <p>It was unknown when the cables/pipes penetrating the cavity barriers above cross corridor doors were installed, if at the time of construction then this defect is considered not to have met the guidance at the time of construction.</p>

<p>Example of inadequately fire stopped cavity barrier above CCD.</p>

<p>Arrange for cavity barriers above cross corridor fire doors to be fire stopped to minimum fire resistance of 30 minutes.</p>	<p>2</p>
---	---	----------

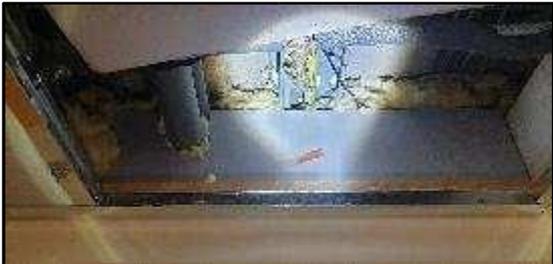
<p>Example (2) of inadequately fire stopped cavity barrier above CCD.</p>		
---	--	--

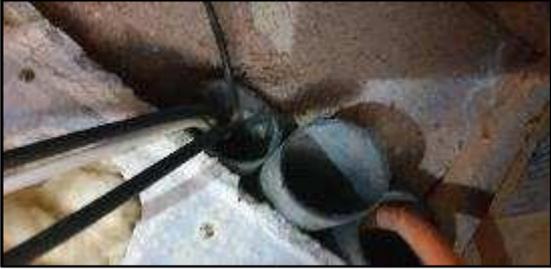
<p>There were a number of service penetrations from communal corridor ceiling voids into flats that were not appropriately fire stopped.</p>

<p>Example of service penetration not adequately fire stopped.</p> <p>The pipes and cables appear to be original and these defects are considered not to have met the guidance at the time of construction.</p>	<p>Arrange for all service penetrations from communal corridors to be adequately fire stopped to a 60 minute fire resisting standard.</p>	<p>3</p>

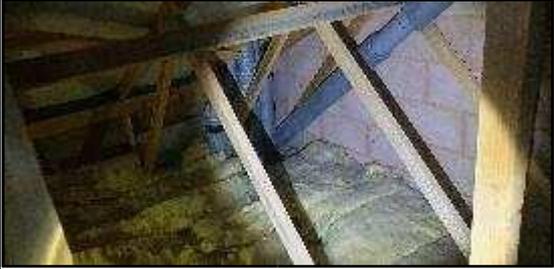
<p>It could not be confirmed that communal vents that discharge from communal risers through the roof voids have been fitted with appropriate fire dampers at openings to flats.</p> <p>These defects are considered not to have met the guidance at the time of construction.</p>

<p>Example of communal vents in roof void</p>	<p>Confirm that all communal vents have been fitted with appropriate fire dampers.</p>	<p>3</p>
---	--	----------
