Passive Fire Protection Review

Site: Cestrian Court (11358)
Address: Newcastle Road,
Chester Le Street,
Durham,
DH3 3TD
Client: FirstPort
Visit Date: 9th July 2020
Author: Joe Nims BSc Hons
Review Date: N/A

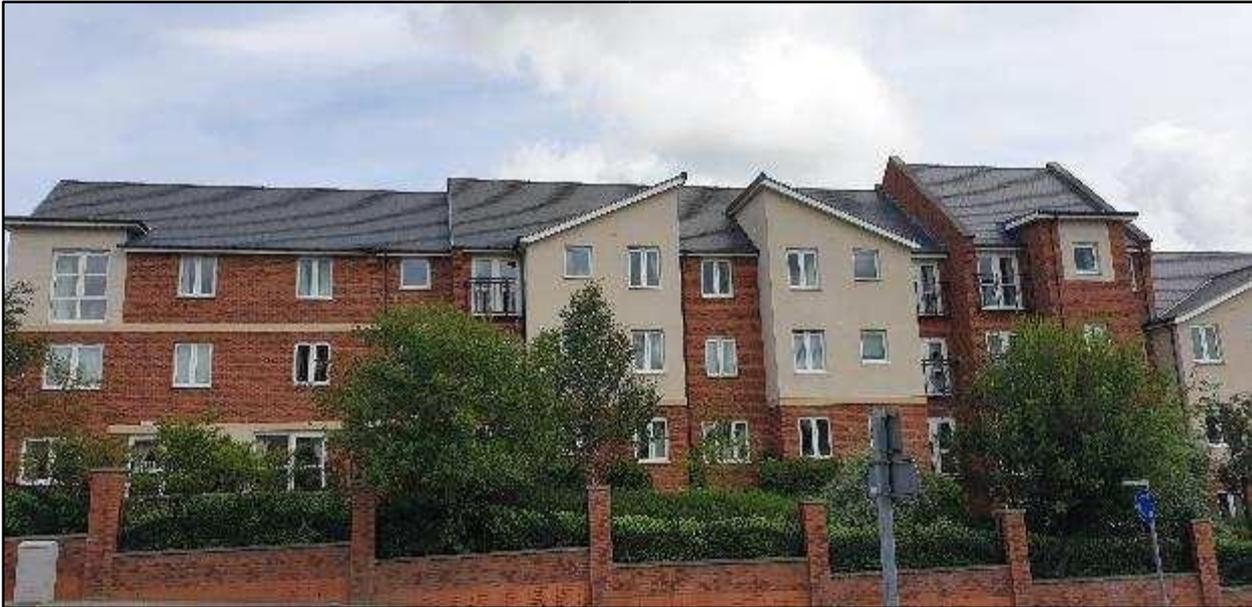
The top floor corridors are covered with concrete slabs which have full length holes connecting roof voids either side of the corridor. Some of the slabs had these holes fire stopped with mineral wool but the majority of these holes were not fire stopped, and some had been covered over with PUR/PIR foam slabs.
